2009 Riparian Health Community Report

- Nose Creek and West Nose Creek -

Alberta Riparian Habitat Management Society
(Cows and Fish)

Nose Creek and West Nose Creek,
Rocky View County, Alberta
(between Airdrie and Crossfield)

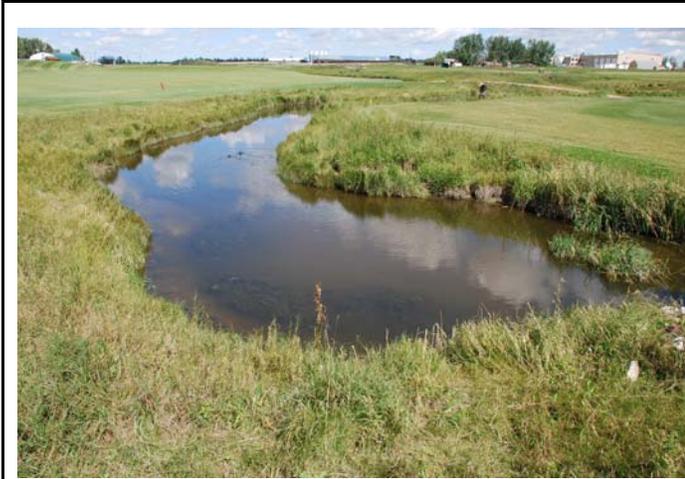
Photo a: Kentucky bluegrass and smooth brome communities dominate the floodplain along much of Nose Creek, particularly in former agricultural fields, golf courses and urban parks. (Photographer: K. Romanchuk, Catalogue Number: RHIP15NOS021).

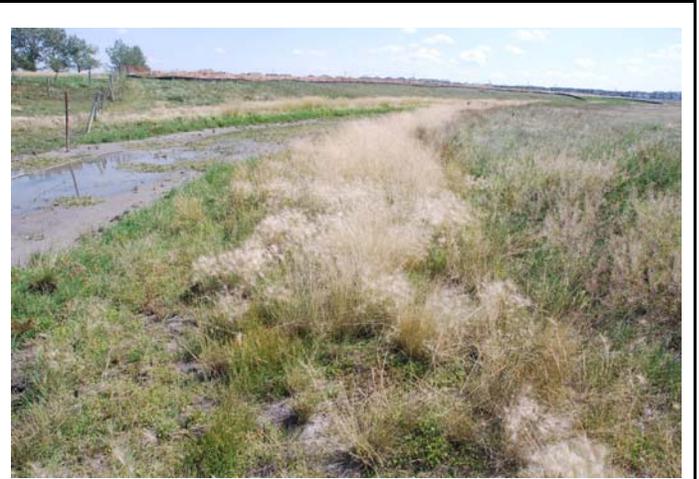
Photo b: The lower floodplain of the Williamstown Environmental Reserve in Airdrie is characterized by saline tolerant plant communities dominated by Nuttall's salt-meadow grass, salt grass, wire rush and foxtail barley (Photographer: K. Hull, Catalogue Number: RHIP22NOS002).

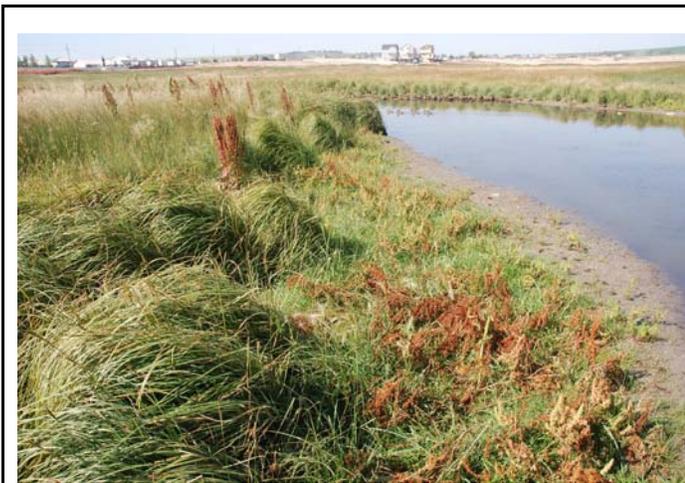
Photo c: Deeply rooted native sedges provide excellent streambank stability and erosion protection. Sedge communities are well established along banks in the majority of the Nose Creek project area. (Photographer: K. Hull, Catalogue Number: RHIP22NOS006).

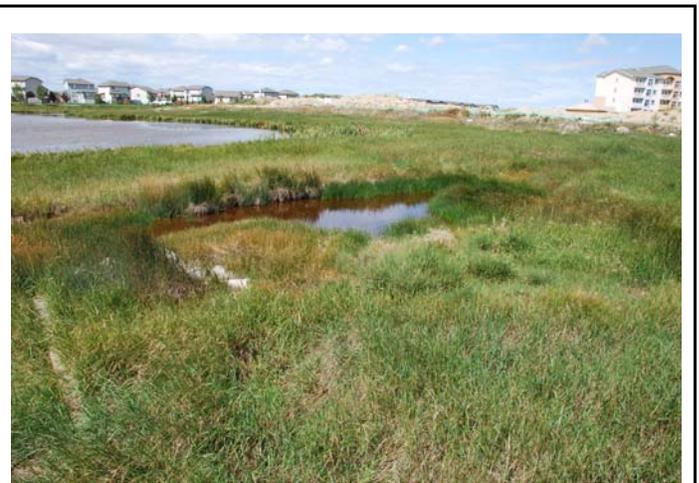
Photo d: Seepage areas along this portion of Nose Creek in Airdrie contain remnant native sedge and rush communities. (Photographer: K. Hull, Catalogue Number: RHIP17NOS027).

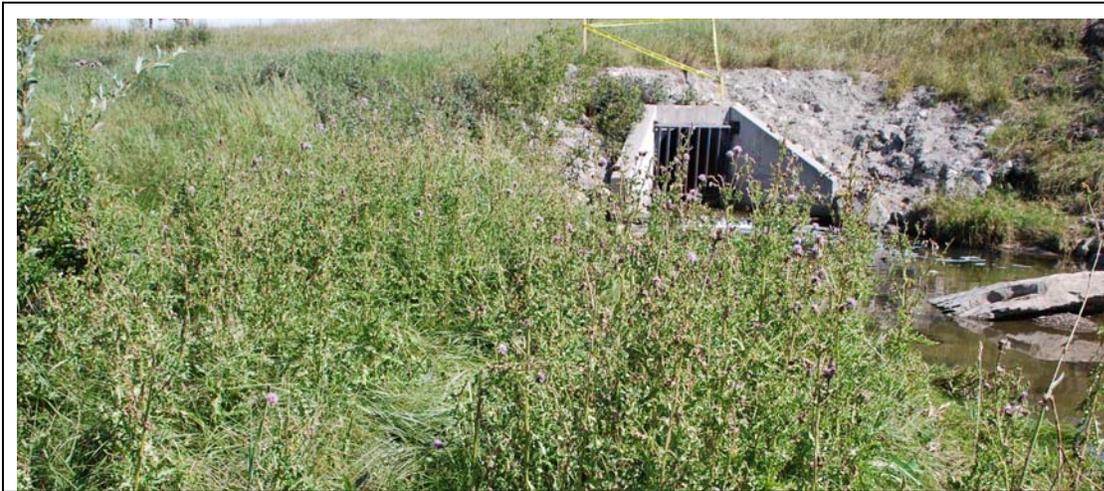
Photographer: K. Hull,
Catalogue Number: RHIP04NOS021

Photo e: A large Canada thistle infestation near a stormwater outfall at the downstream end of the Nose Creek Park site in Airdrie.

- Invasive plants were recorded in all of the sites. Canada thistle (*Photo e*) and secondarily smooth perennial sow-thistle are most abundant and widespread in the project area. Ongoing weed monitoring and control will help reduce and prevent further spread of these species. Invasive weeds encroach quickly into areas of natural or human caused bare ground such as disturbed berms resulting from construction activities (*Photo f*).

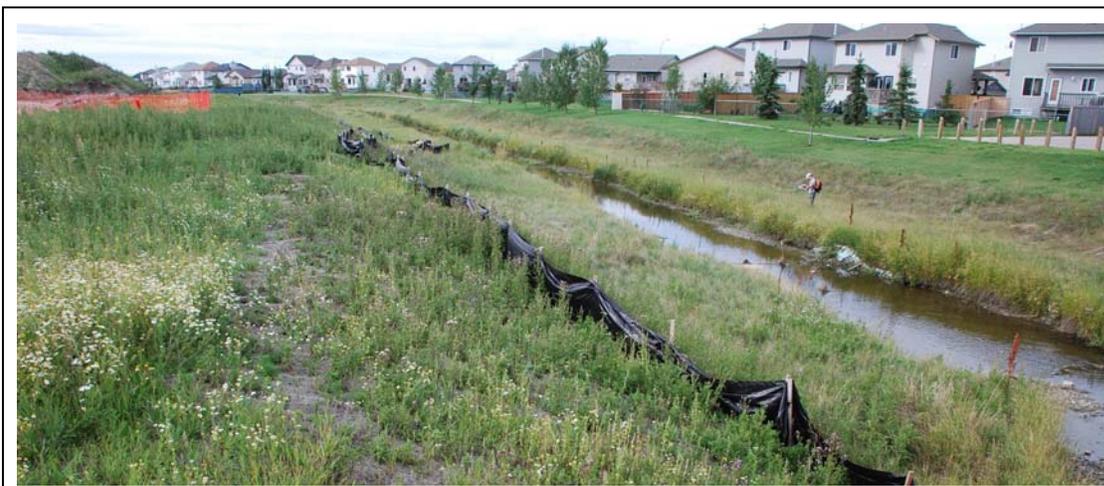
Photographer: K. Hull,
Catalogue Number: RHIP17NOS019

Photo f: This disturbed berm adjacent to a recently channelized stretch of Nose Creek in Willow Brook Park in Airdrie is infested with Canada thistle and a large population of scentless chamomile.

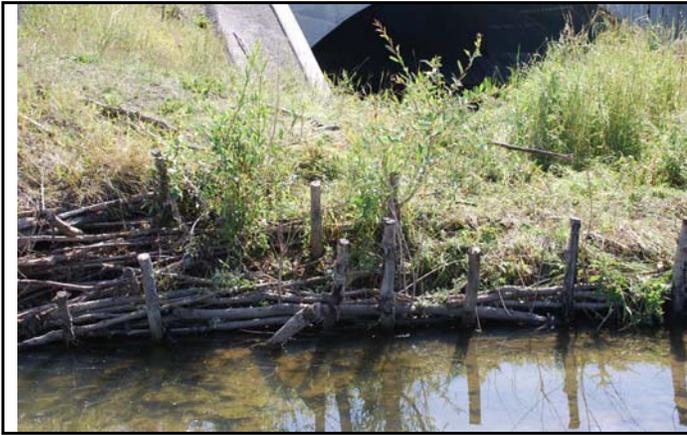
Photo g: Live willow cuttings and wattle fences were installed along this eroded bank in 2006 as part of a soil bioengineering workshop. This portion of bank is located adjacent to a stormwater outfall at the downstream end of Nose Creek Park in Airdrie. (Photographer: K. Hull, Catalogue Number: RHIP04NOS020).

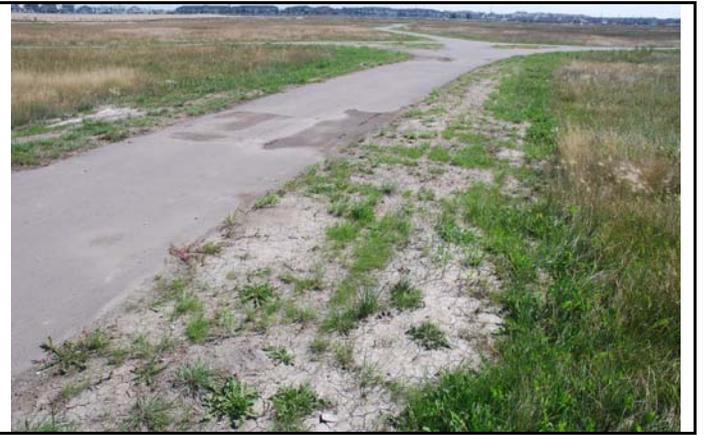
Photo h: Bare ground adjacent to recently constructed paved trails in the Williamstown Reserve has been seeded with a native seed mix, but it also has good potential for natural recovery. (Photographer: K. Hull, Catalogue Number: RHIP22NOS012).

- Most sites have minimal (i.e. less than 5%) or only trace amounts (i.e. less than 1%) of human-caused bare ground.
- Human-caused bare ground in the project area is mainly attributable to recent construction activities associated with berms, stormwater outfall structures, or pedestrian pathways and / or foot bridges (*Photo h*, page 20). Only a trace amount of bare ground is from recreational impacts such as undesignated trails (from bikes, people or dogs). A small amount of human-caused bare ground has also resulted from erosion of culvert crossings (*Photo i*, page 20) and from sandpit developments in the golfcourse fairways. Most areas of human-caused bare ground have the potential to recover fairly rapidly with appropriate restoration strategies. Bare ground in Airdrie parks may need to be restored using native shrub and graminoid plantings. There is greater potential for localized areas of bare ground in the Williamstown Environmental Reserve site to naturally recover since native plant communities are well established in this site (*Photo h*, page 20).

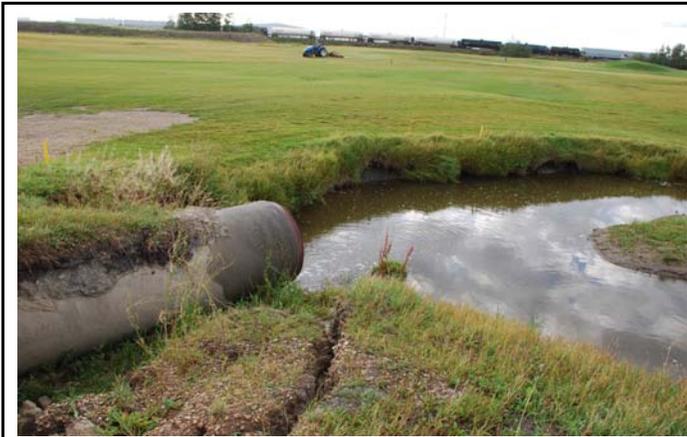
Photo i: Bare ground has resulted from erosion of this culvert crossing in the golf course site. Soil compaction and landscaping due to fairway developments have caused streambank and floodplain alterations. (Photographer: K. Romanchuk, Catalogue Number: RHIP15NOS023).

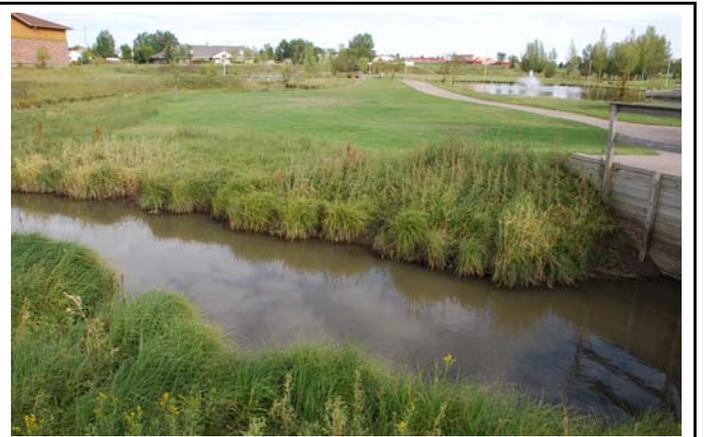
Photo j: Deeply rooted native sedges are providing good root mass protection along this stretch of Nose Creek in Nose Creek Park; however landscaping and mowing have caused soil compaction in the floodplain. (Photographer: K. Hull, Catalogue Number: RHIP04NOS028).

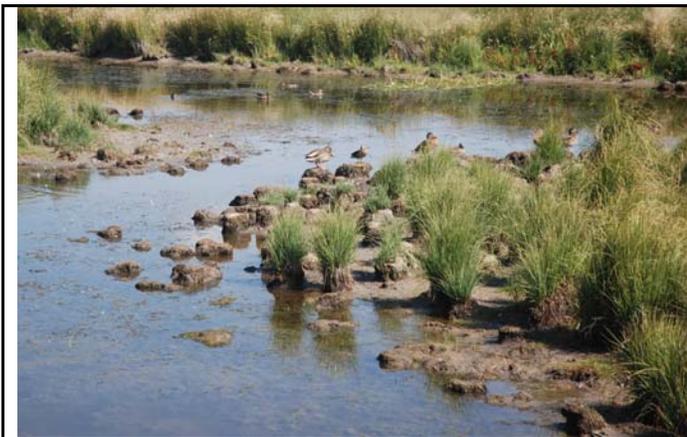
Photo k: Residual trampling impacts from historic livestock use are still apparent along the streambank in the Williamstown Environmental Reserve. (Photographer: K. Hull).

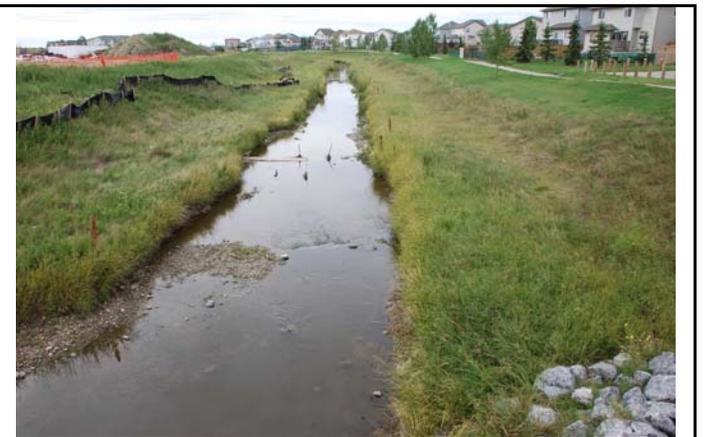
Photo l: Channelization of Nose Creek in Willow Brook Park in Airdrie has caused loss of riparian habitat and may lead to higher downstream erosion. (Photographer: K. Hull, Catalogue Number: RHIP17NOS018).

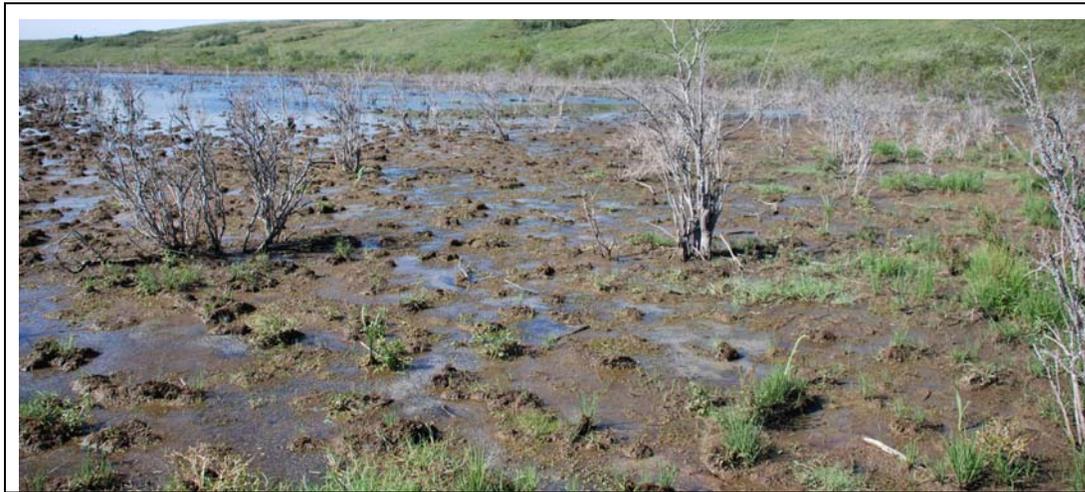
Photographer: K. Romanchuk
Catalogue Number: RHIP23WNO012

Photo m: Beaver dams have caused flooding of this site leading to die out of a portion of the willow community. This is a natural part of the successional process of riparian communities in beaver modified habitats.

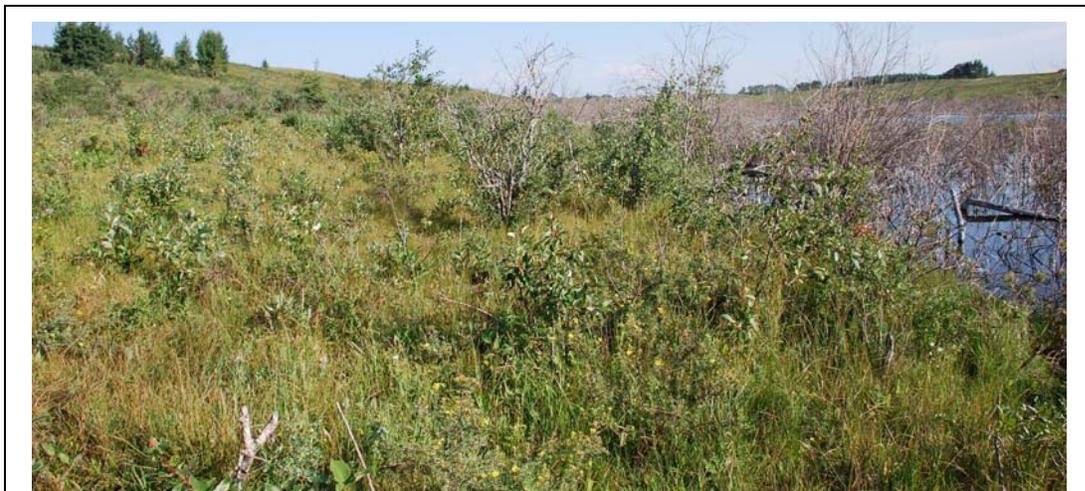
Photographer: K. Romanchuk,
Catalogue Number: RHIP25WNO006

Photo n: Beaver removal of willows, aspen and balsam poplar has been offset by an abundance of new growth. These types of native woody plants are well adapted to beaver disturbance by their ability to regenerate vegetatively. Cut willow stems quickly send out new shoots using stored root reserves.

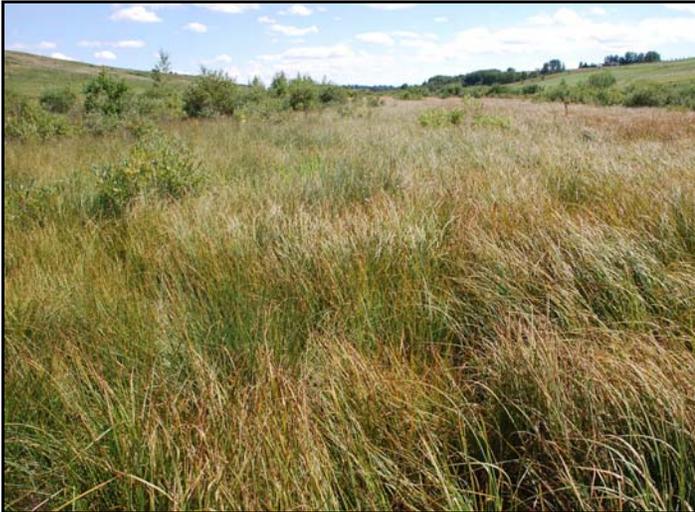
Photo o: The West Nose Creek valley bottom is characterized by wide, vigorous and productive native sedge communities. (Photographer: K. Hull, Catalogue Number: RHIP07WNO008).

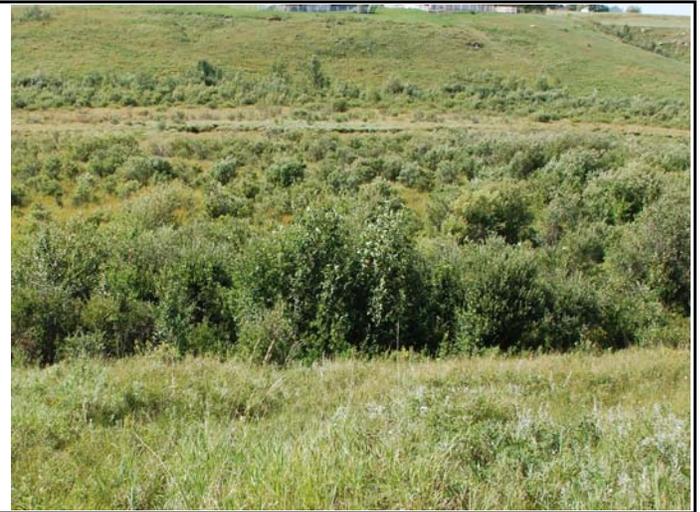
Photo p: All of the West Nose Creek sites we assessed have healthy, diverse native tree and shrub communities. Beaked willow is the dominant shrub in all sites. (Photographer: K. Hull, Catalogue Number: RHIP24WNO011).

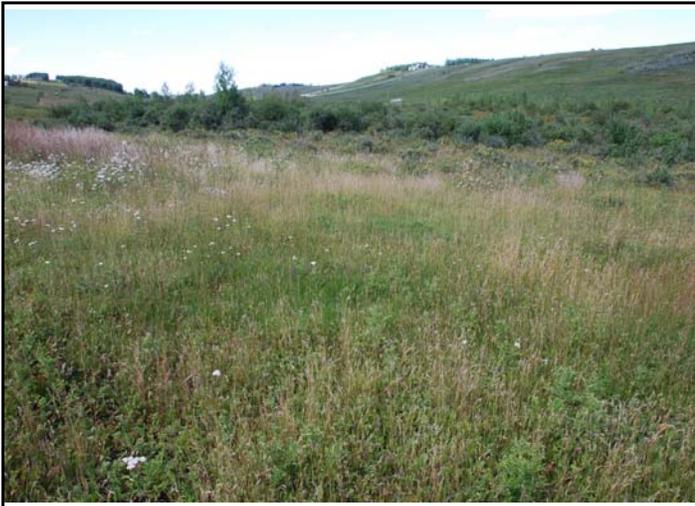
Photo q: Disturbance caused plants, mainly Kentucky bluegrass and white clover, are encroaching along the periphery of a few sites. These plants encroach from adjacent cropland or heavily grazed pastures. (Photographer: K. Hull, Catalogue Number: RHIP07WNO018).

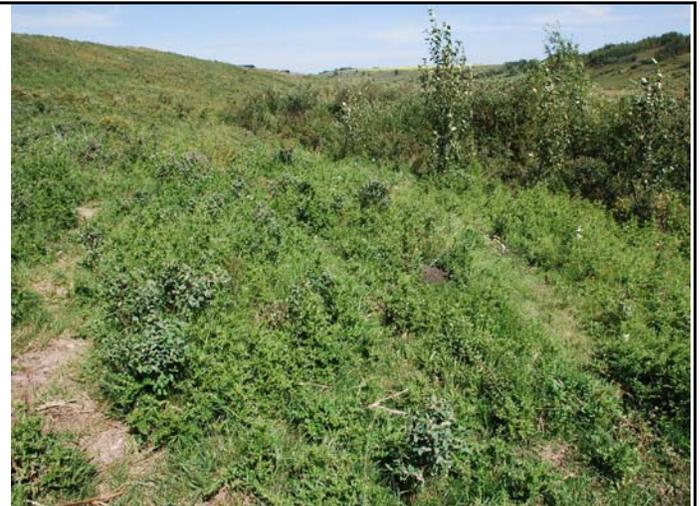
Photo r: Canada thistle is fairly abundant along side slopes of the West Nose Creek valley. Thistle infestations along the valley slopes are beginning to invade into the outer edges of the riparian area. (Photographer: K. Hull, RHIP23WNO13).

- Canada thistle is particularly abundant in two of the sites where it is mainly invading from the adjacent valley slope (*Photo r*, page 28). Adjacent croplands, hayfields, roadways and historical horse and cattle grazing along the valley has contributed to the establishment and spread of Canada thistle.

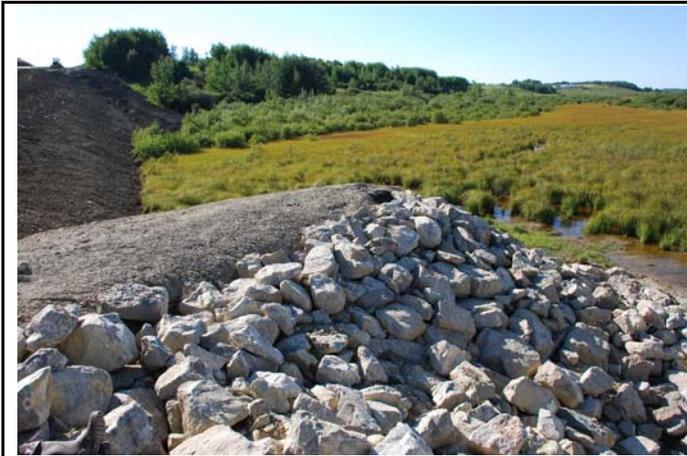
Photo s: New road construction along the south end of the Rocky View Environmental Reserve. Rip-rap has been installed at the culvert. Roads and culverts have potential to alter natural subsurface and surface hydrology. Long-term monitoring is suggested to examine these effects. (Photographer: K. Hull, Catalogue Number: RHIP07WNO013).

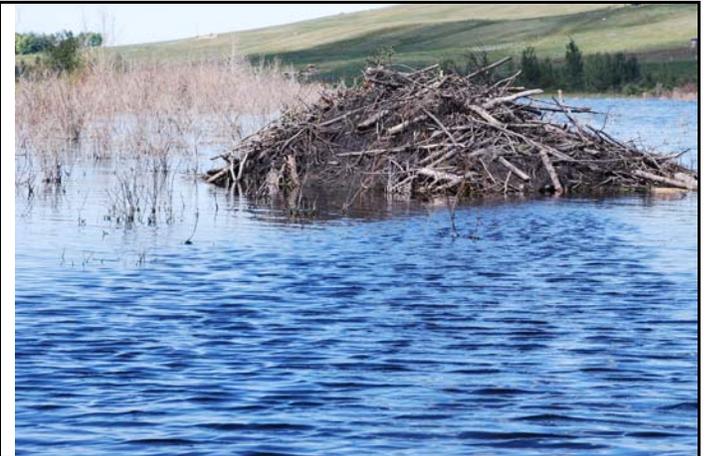
Photo t: Beaver activity is common in the West Nose Creek valley. There are several active beaver lodges and recently built dams in the project area. (Photographer: K. Hull).

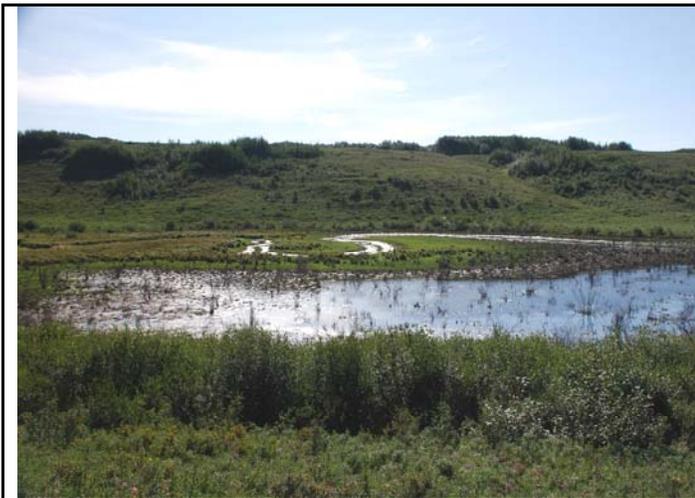
Photo u: Two of the sites in the project area have been recently flooded by beaver dams. Beaver ponds like this one help to trap sediment, slow stream flows and reduce erosion, recharge aquifers, and provide habitat for wetland wildlife species. (Photographer: K. Romanchuk, Catalogue Number: RHIP23WNO007).

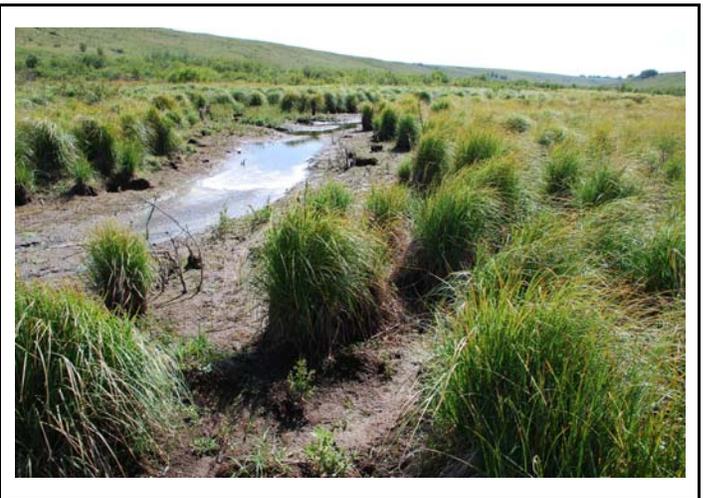
Photo v: Fine textured soil in the valley bottom is easily susceptible to trampling impacts from wildlife and livestock use. This creates raised mounds of soil and depressions from hoof impacts, contributing to soil compaction. (Photographer: K. Hull, Catalogue Number: RHIP24WNO002).

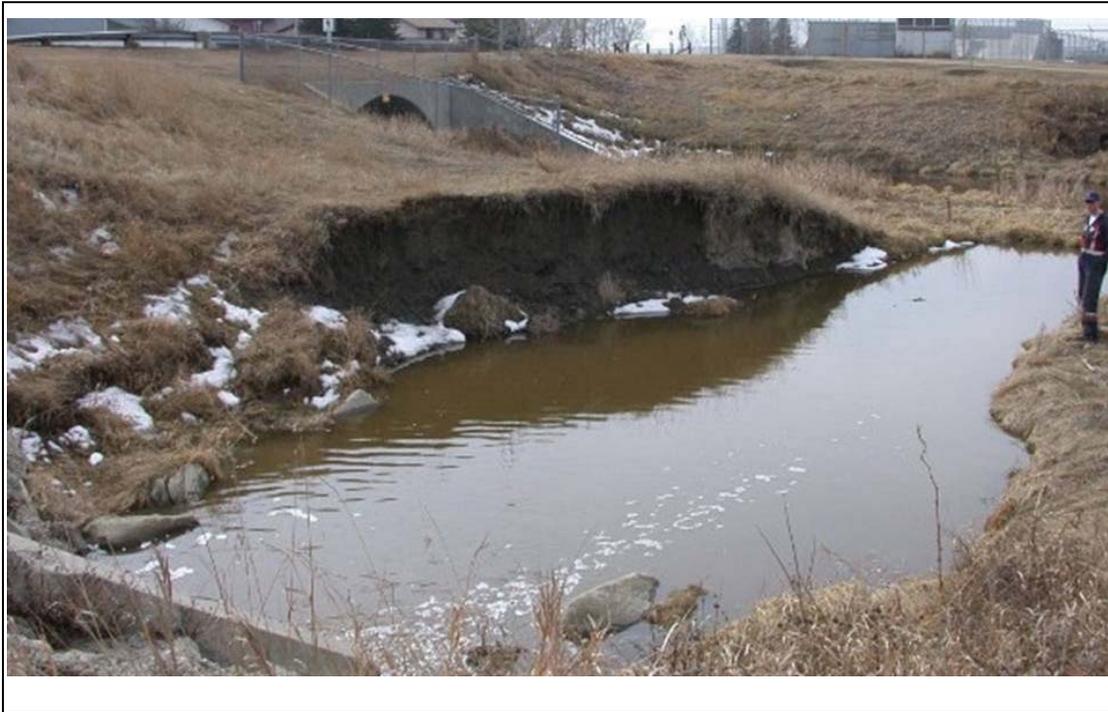
Photo w: Pre-restoration photograph (2006), showing eroded bank downstream of a stormwater outfall at the downstream end of the Nose Creek Park riparian inventory site.

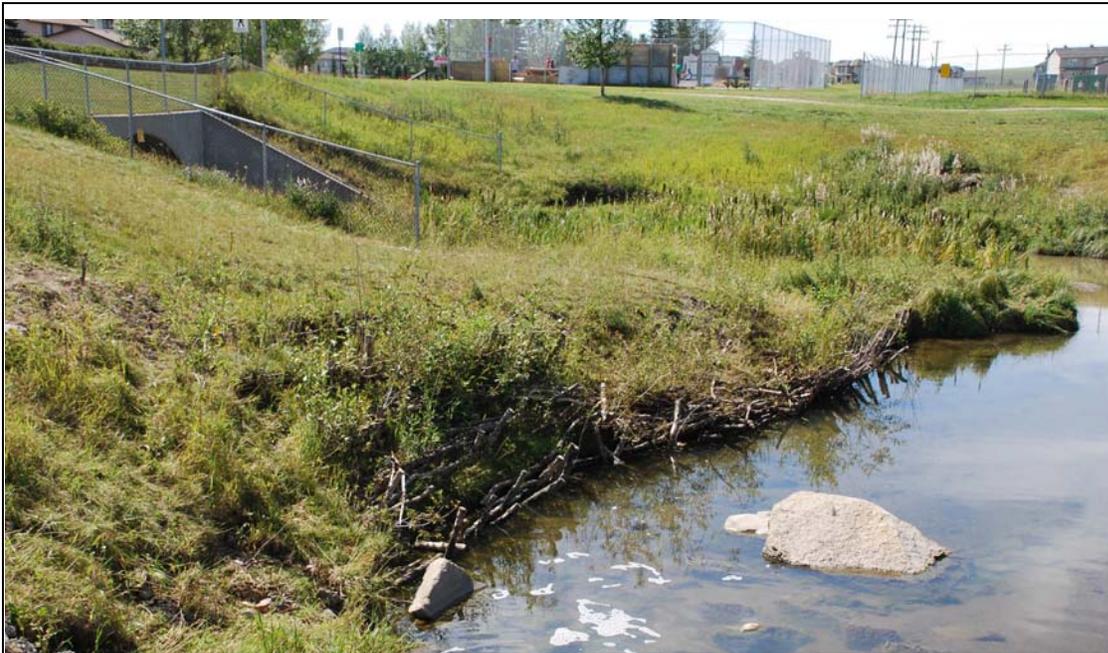
Photographer: K. Hull,
Catalogue Number: RHIP-17NOS022

Photo x: Bioengineering techniques (i.e. live willow fences) employed in 2006 remain intact. This photograph taken in 2009 shows that live willow cuttings have helped to stabilise and reshape the bank. There is now reduced erosion along the bank and the willow stems are helping to build out the bank by trapping sediment. Some additional willow fencing may be needed to reinforce this bank as there has been some willow mortality since 2006.

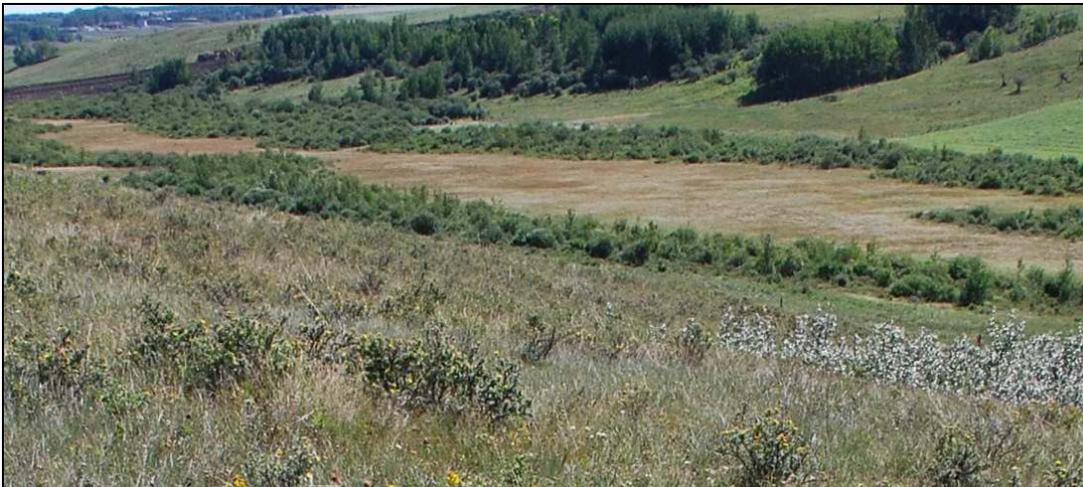
Photographer: K. Hull
Catalogue Number: RHIP07WNC015

Photo y: The West Nose Creek Environmental Reserve has excellent representation of native sedge and willow communities in the riparian area. Native grassland is intact along the east valley slope.

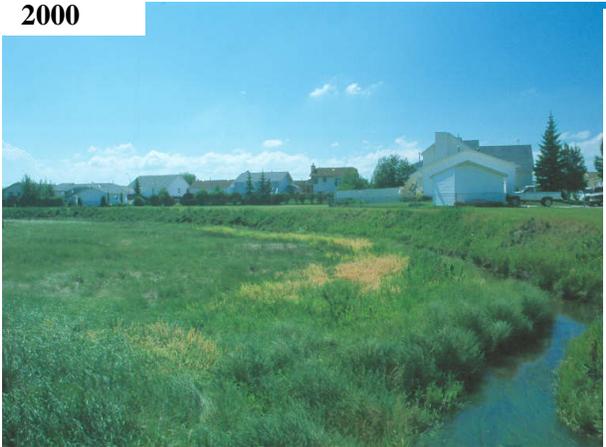
S. Witham, RHIP04NOS002

NOS4U Upstream end looking downstream. The floodplain is well vegetated although disturbance-caused grasses are prevalent.

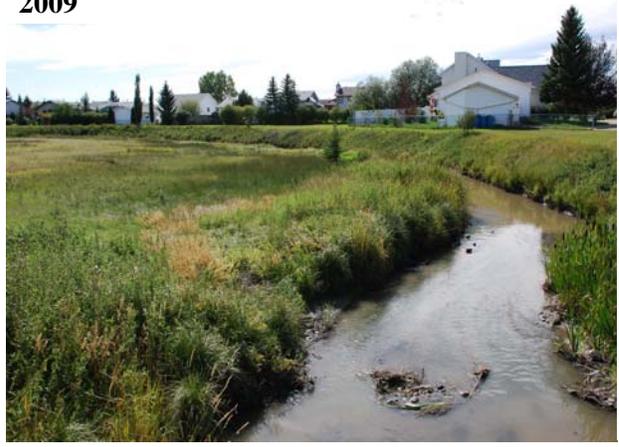
K. Hull, RHIP04NOS012

NOS4U Upstream end looking downstream. The floodplain and banks remain well vegetated. Native plant cover along the banks has improved since 2000.

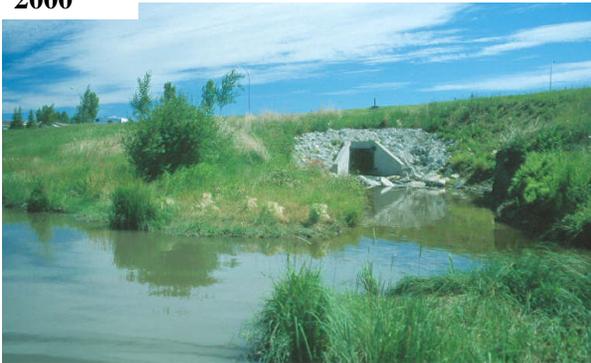
S. Witham, RHIP04NOS004

NOS4L Downstream end looking upstream. Bank slumping is apparent due to a lack of deeply rooted native plants at this location.

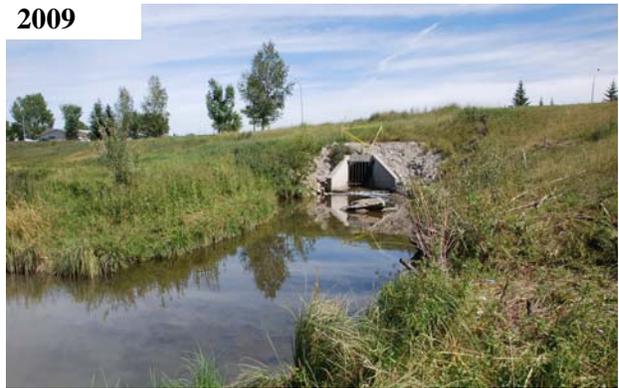
K. Hull, RHIP04NOS016

NOS4L Downstream end looking upstream. Willows planted here in 2006 (as part of a soil bioengineering project) may have been impacted in 2008 during the repair of a ruptured water pipe.

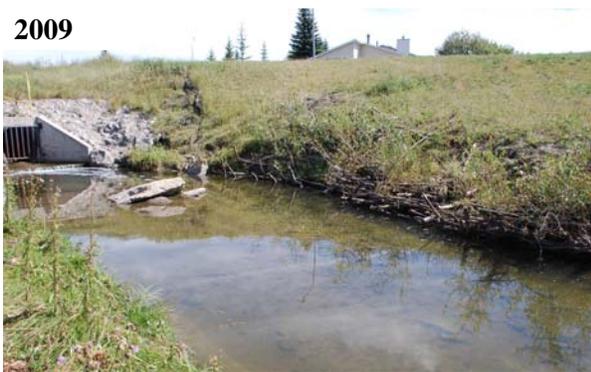
K. Hull, RHIP04NOS018

NOS4A Close-up view of the bioengineering site at the downstream end. Wattle fencing is intact, but additional reinforcement may be needed.

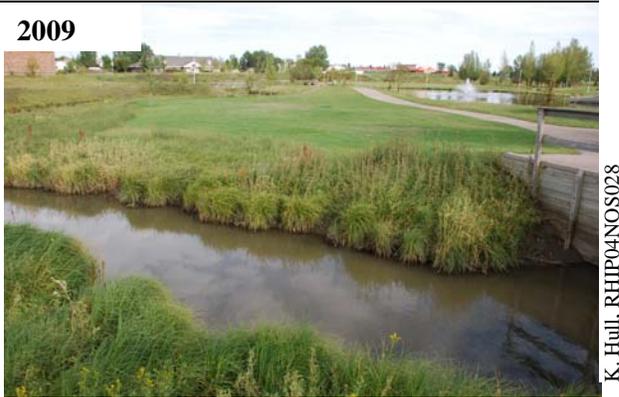
K. Hull, RHIP04NOS028

NOS4G There is an excellent band of deeply rooted native plants along most of the streambank. Where possible, a wider band of natural riparian vegetation should be protected from mowing to improve infiltration capacity in the floodplain and to reduce runoff rates.

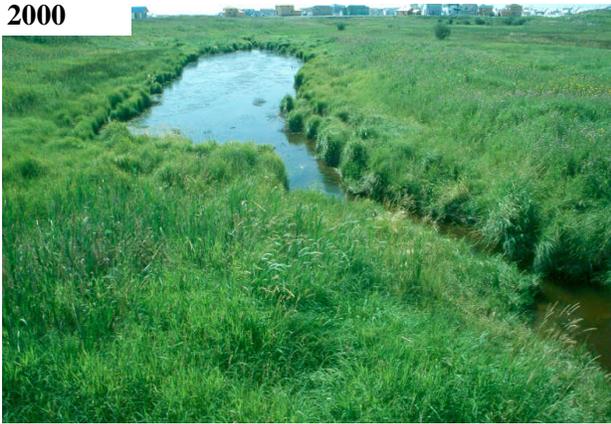
K. O'Shaughnessy, RHIP17NOS002

NOS17U Upstream end looking downstream. The floodplain is well vegetated and the channel has natural meander bends.

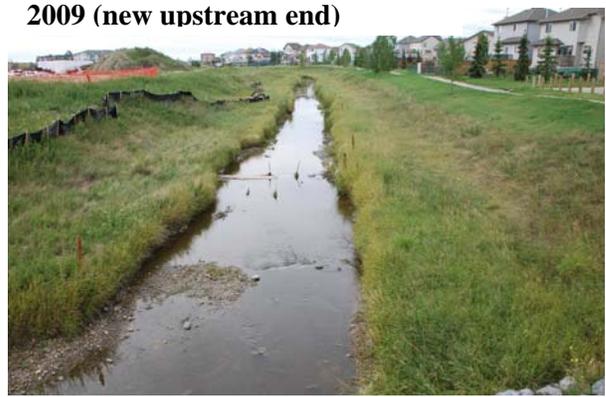
K. Hull, RHIP17NOS018

NOS17U Upstream end looking downstream. This portion of Nose Creek has been channelized since 2000. This has created channel incisement and loss of riparian habitat.

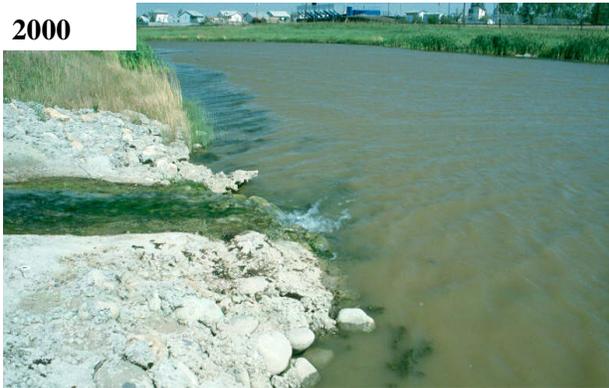
K. O'Shaughnessy, RHIP17NOS004

NOS17L Downstream end looking upstream. Channelization and berms have contributed to lateral (outward erosion) of the stream channel.

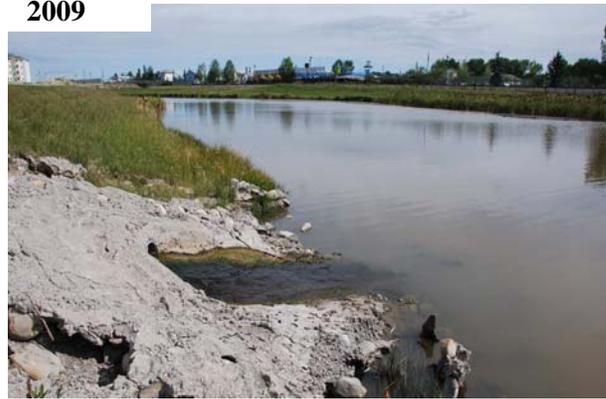
Hull, RHIP17NOS021

NOS17L Downstream end looking upstream. The downstream portion of the site has not changed appreciably since 2000. Introduced grasses seeded along the bermed west bank offer little root mass protection or fish habitat value.

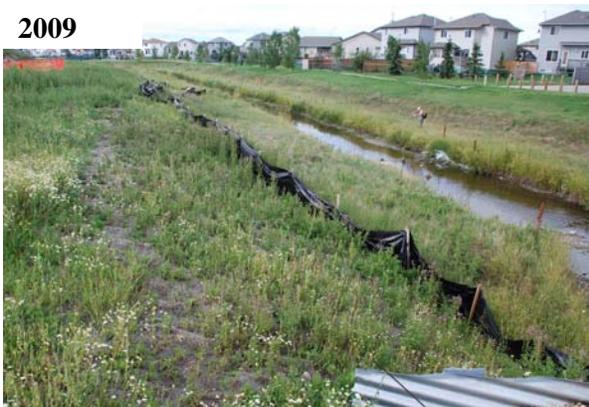
K. Hull, RHIP17NOS019

NOS17U Weed monitoring and control is needed along the newly constructed berm at the upstream end (on the east side of the creek).

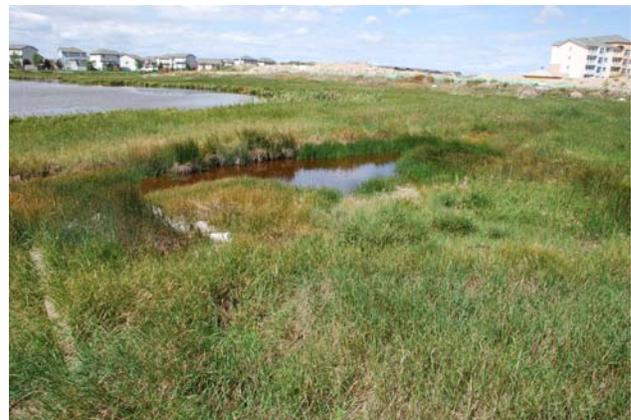
K. Hull, RHIP17NOS027

NOS17F Natural seeps / springs occur on the east side of the creek opposite the storm pond. This portion of the site has remnant, intact native riparian plant communities.

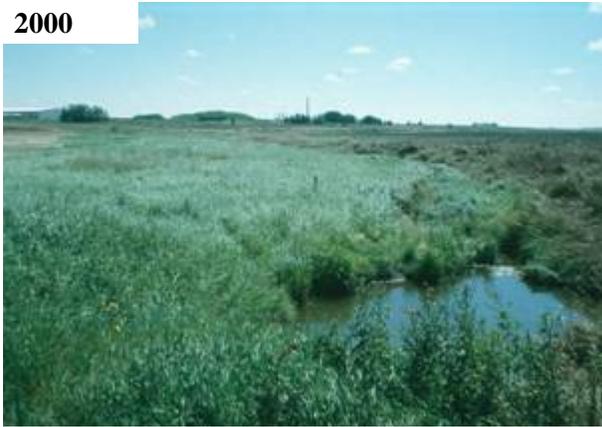
NOS15U Upstream end looking downstream. Canada thistle patch in foreground. Good vegetation cover and wide riparian buffer. Narrow creek channel.

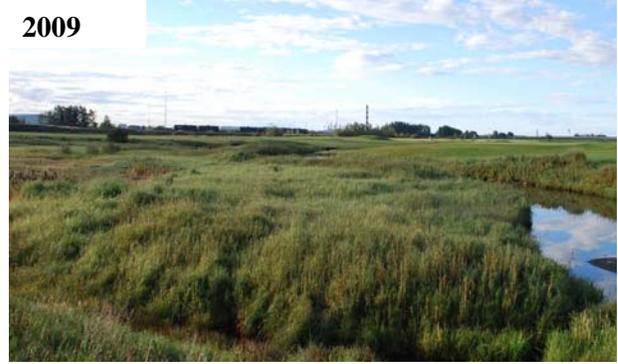
NOS15U Upstream end looking downstream. Golf course development has reduced the width of the riparian buffer on the east (right) side of creek. The creek channel is wider due to an ice jam at the culvert crossing. Canada thistle cover has increased.

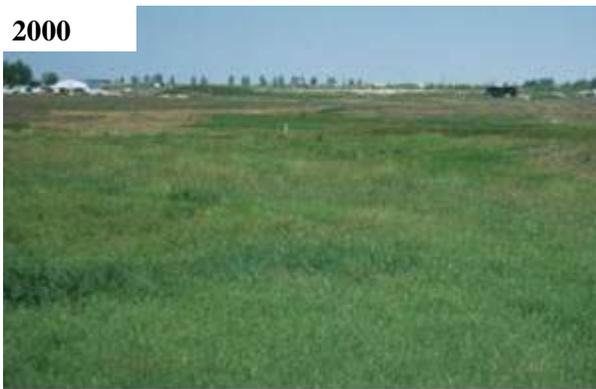
NOS15A Note the wide vegetated riparian buffer and excellent root mass protection along Nose Creek from deeply rooted grasses and sedges.

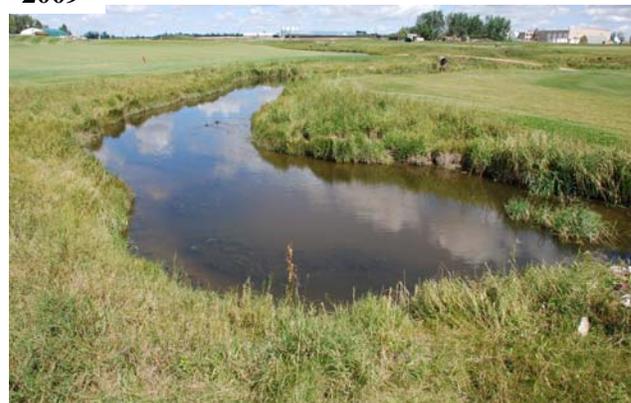
NOS15A Much of the riparian area has been converted to golf course fairways. This has created soil compaction, reduced root mass protection along the banks, reduced runoff filtration capacity, and less habitat for fish.

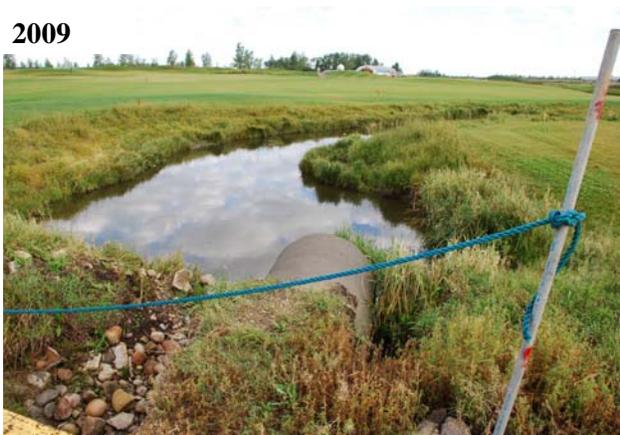
NOS15A Culvert crossings constrict water flows creating ice jams, erosion and bank slumping. This increases sediment inputs into the stream, decreasing water quality.

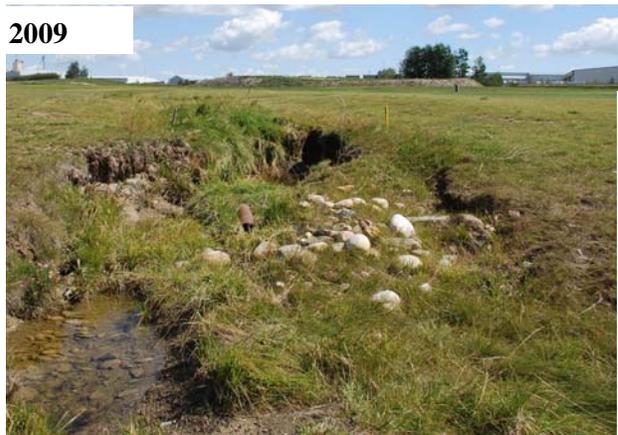
NOS15D Erosion along a small tributary that flows into Nose Creek near the upstream end on the east side of the creek. Lack of a riparian buffer is contributing to erosion.

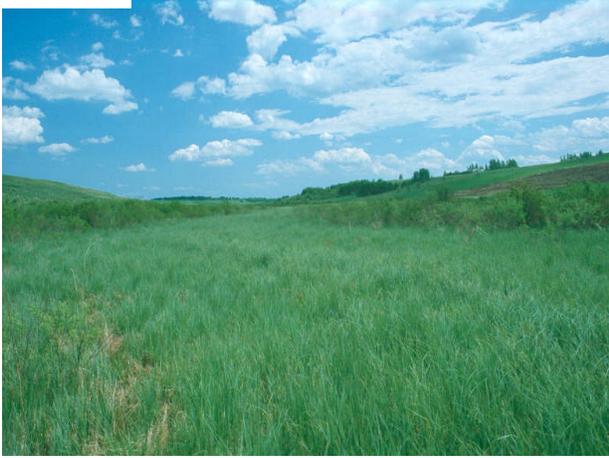
A. Markiewicz, RHIP07WNO001

WNO7U Upstream end looking downstream. Excellent vegetative cover of the floodplain.

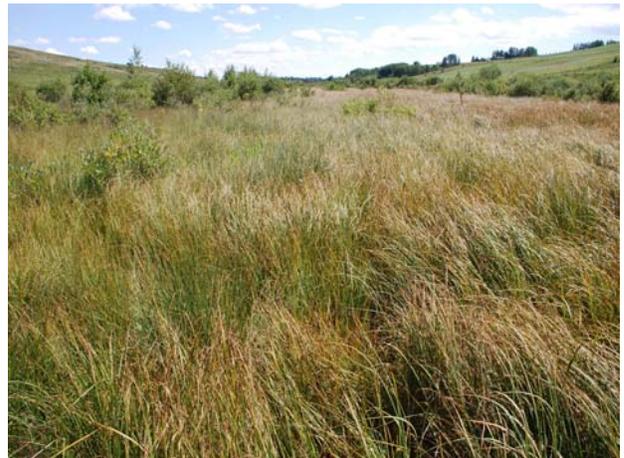
K. Hull, RHIP07WNO008

WNO7U Upstream end looking downstream. The riparian area remains fully vegetated with water sedge and beaked willow communities. Vegetative cover is important for reducing erosion, trapping sediment and stabilising banks, and for providing forage and shelter for wildlife.

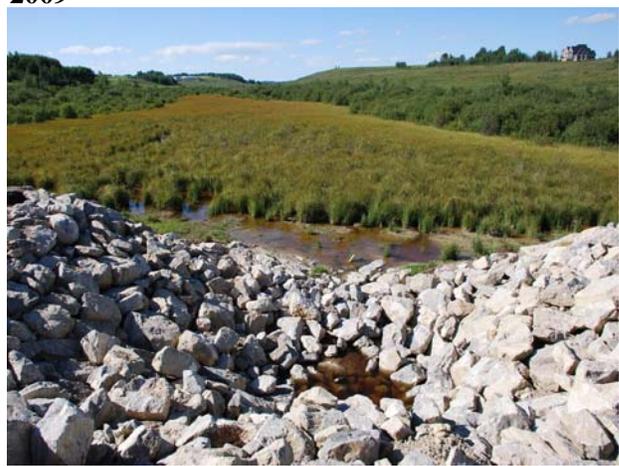
K. Hull RHIP07WNOS012

WNO7L Downstream end looking upstream. The wide, robust sedge channel in the middle of the valley persists. Road construction activities have occurred since 2000. A new culvert crossing and associated rip-rap has been installed at this end of the site.
